59-0139
18 MAY 61

REPORT OF AF AIRCRAFT ACCIDENT

AIRCRAFT ACCIDENT F-106A 54H 59-0139 18 MAY 1961

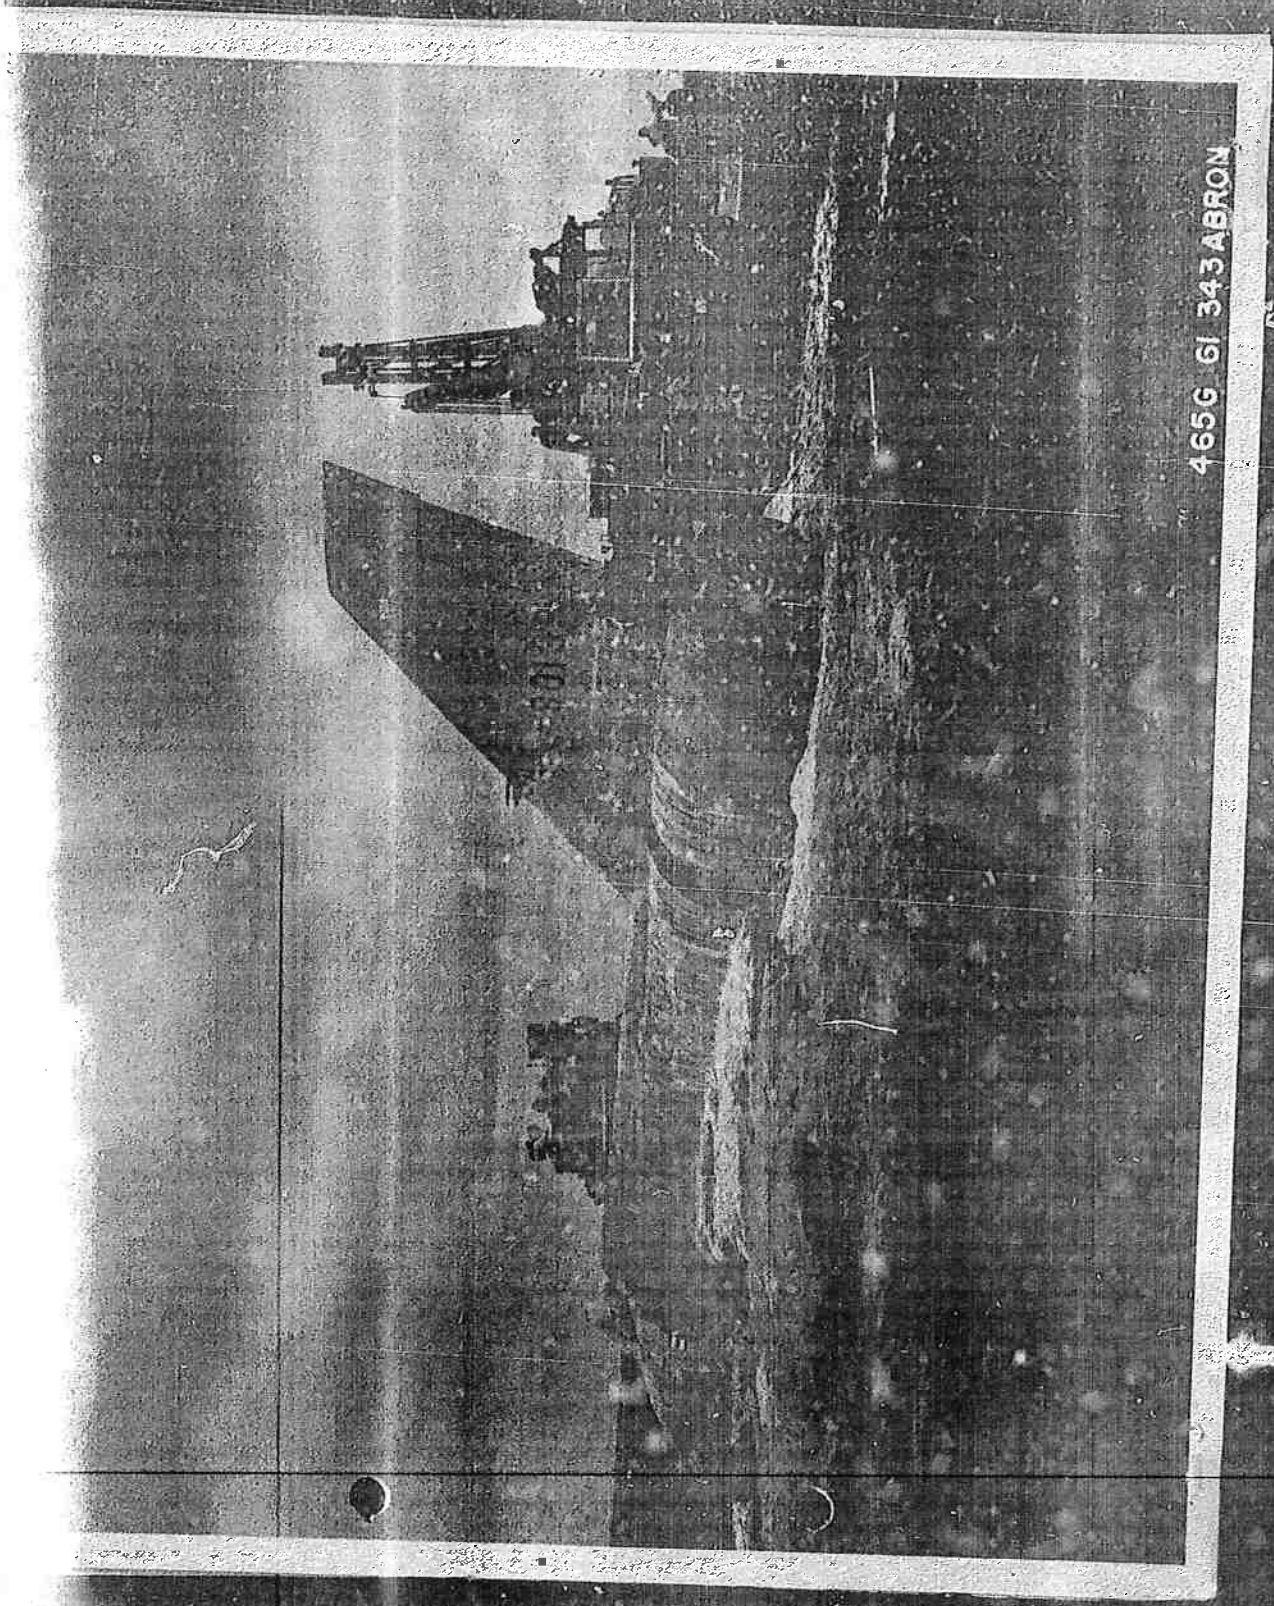
DIAGRAM II

up to the overrun (see Tabs Q diagram 2 & Tab R). UH 26E burst into flames immediately upon impact, driving both main landing gear into the wings. The landing gear then sheared from the aircraft (see Tab Q diagram 2). The aircraft slid up on to the overrun and continued to slide down the runway shedding pieces and spraying the runway with fuel (see Tab Q diagram 1). The BAK-6 barrier supported by rubber grommets, located 530 feet from the runway threshold, was in position. This was not taken down prior to the landings as there was insufficient time for the service crew to remove it. The runway landing direction was changed only for these six (6) aircraft. UH 26E slid over this BAK-6 barrier apparently snapping the cable upon passing over it. UH 26E began veering to the left, leaving the runway 3,100 feet from the threshold lights. He continued to slide another 400 feet and came to a rest 150 feet left of the runway, 20 degrees from the runway heading (see Tab Q diagram 1). While the aircraft was sliding, Lt. Deneklau the pilot, unfastened the two (2) parachute clasps to release him from the rotational upward ejection Type B seat and the incorporated parachute. After stopping, Lt. Deneklau started to open the canopy normally. He then noted the flames and decided to jettison the canopy which departed the aircraft when he raised the ejection lever on the left side of the seat. He immediately raised himself out of the seat and abandoned the aircraft over the right side. He was met by the fire department who turned him over to the flight surgeon a few minutes later (see Tab G). The fire department responded almost immediately to the tower alert call of the crash, managed to control the fire, eventually extinguishing it completely. UH 26D continued his landing roll uneventfully. UH 26C circled the base until the runway was cleared of the major portions of the debris. He then landed without incident.
