The Real Story of the F-106 “509 Accident”

F-106A 57-2509, 84th FIS Hamilton AFB, CA

from a pilot who was in it

Michael E. (Mickey) Rountree, LtCol USAF (Ret)

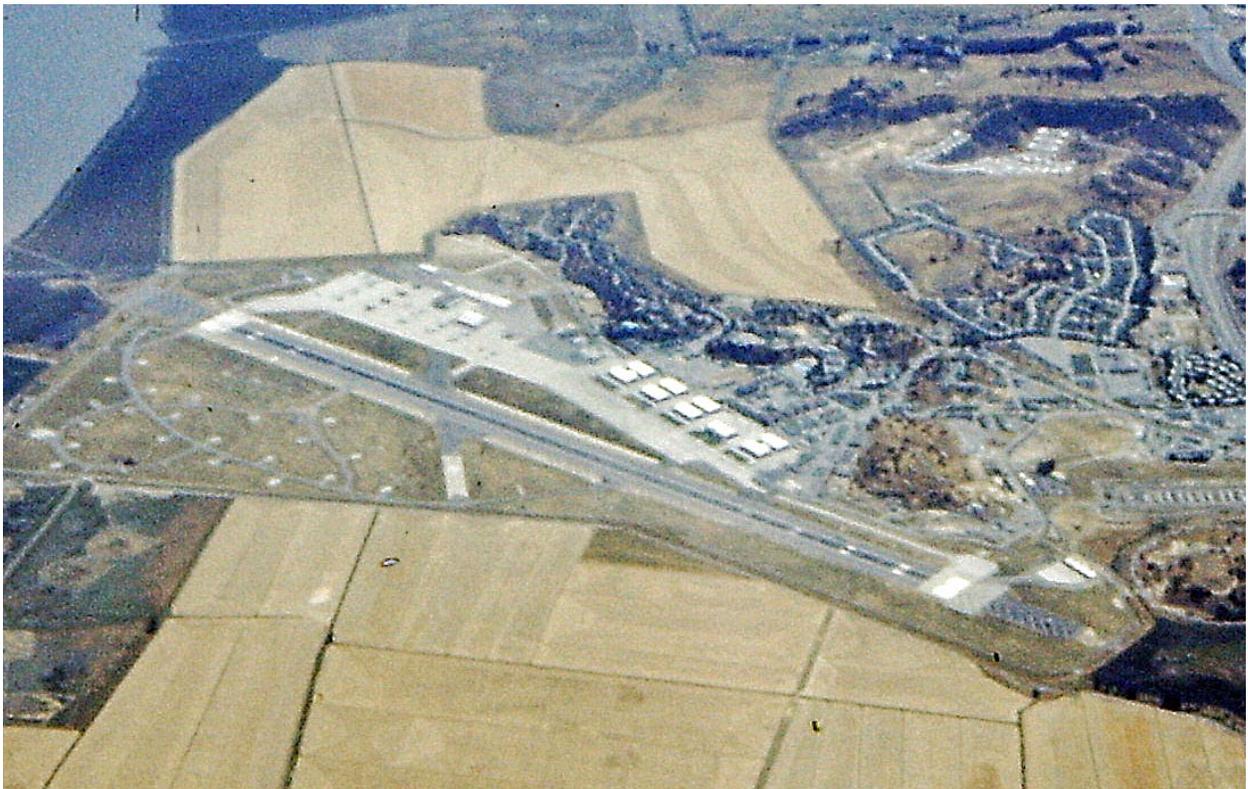
Fig 1. Hamilton AFB in 1972

The runway at Hamilton was quite different from most. First, it was not short. It was twelve thousand feet (about two miles) long, plus overruns, significantly longer than most fighter bases. BUT, it was also **400 feet wide** – this fact, plus the long length, are very significant to understanding why the crash happened. The standard runway is 150 feet wide. At Hamilton there were big white stripes at the standard 150 foot width. These lines were a primary visual reference during daylight landings (see photo above). But at night it is not the paint stripes you see during the day, but rather the runway lights. Runway lights are set just off the edge of the runway. So, a standard runway has rows of lights that are about 170 feet apart; but at Hamilton they were about 420 feet apart – about three times the standard. This arrangement contributed to the visual illusion that led to the accident. Also, the runway overrun on the south end actually sloped down to the runway, starting at the dyke – so, on a normal landing; you could barely see the overrun during approach, day or night. And if you were low, you could not see it at all.

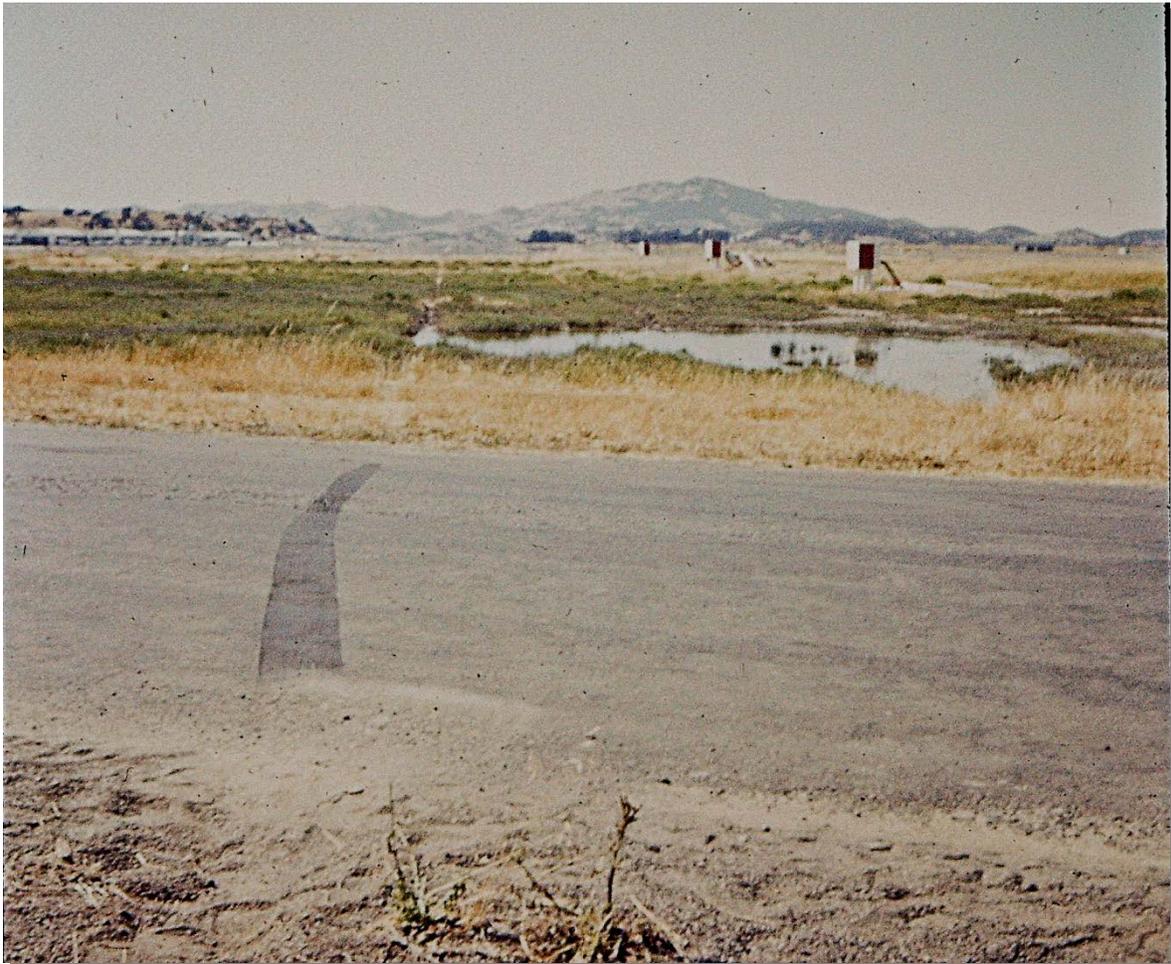
Fig 2. My Impact and Run-out

You may note that there is only one tire track – that's because as soon as I saw sparks under lead, I banked left to get separation. You may note that from here you cannot see the runway because of the up-sloped overrun. Also, note that first contact happened just inches

below the top of the road. If you go backwards from that road you have a dyke, with about 15 degree banking. If I had been just a few feet lower, that dyke would probably have been the end of the aircraft, and perhaps, me too. But, we both got up and around, and I rejoined to assess the situation with lead.

The picture also shows the last few centerline approach lights that lead hit about a quarter mile back, over the water, and were built with heavy timbers and metal. Those are what tore apart 509's left main gear, and the left fuel tank was ripped open.

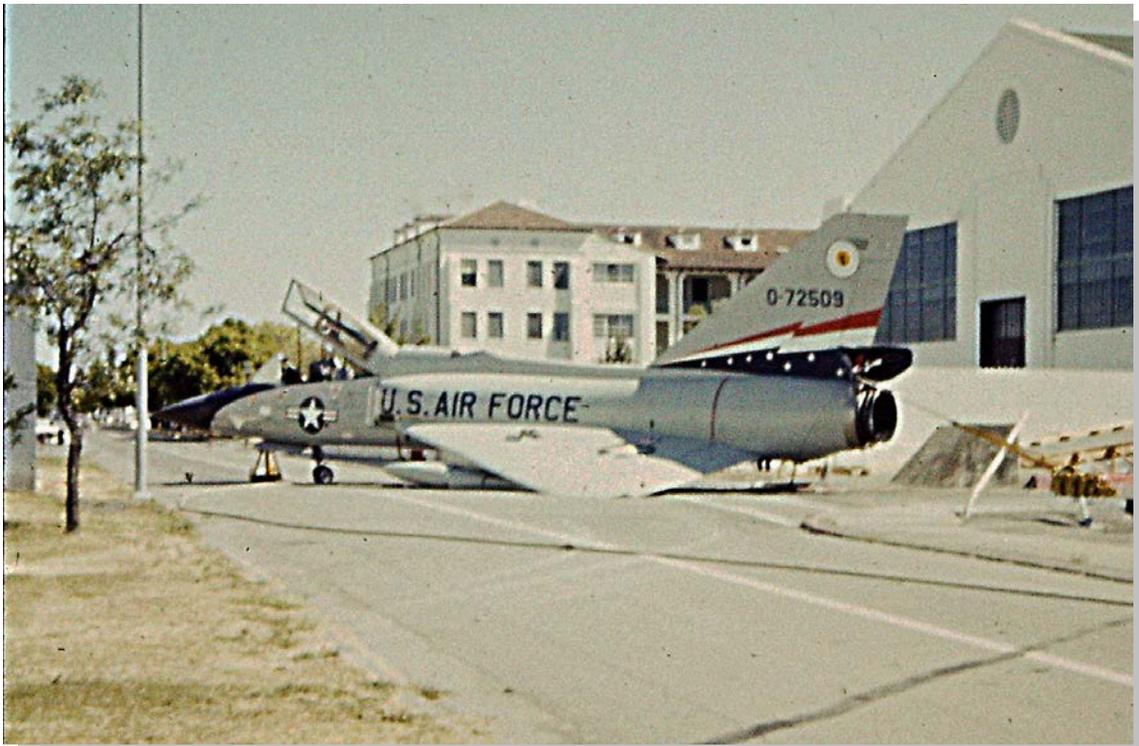
Fig 3. 509 Resting Place

Everyone knows the end of the mission of 509, with my good friends Bill and Gary on board. Once they lowered the nose, with the left main torn away, they were on an uncontrollable ride. Figure 3 is the most famous image of the final resting place. In order to get to that place, on Hanger Ave. they had to thread through several parked aircraft on the ramp, then between two permanent (concrete) hangars, all the time uncontrolled.

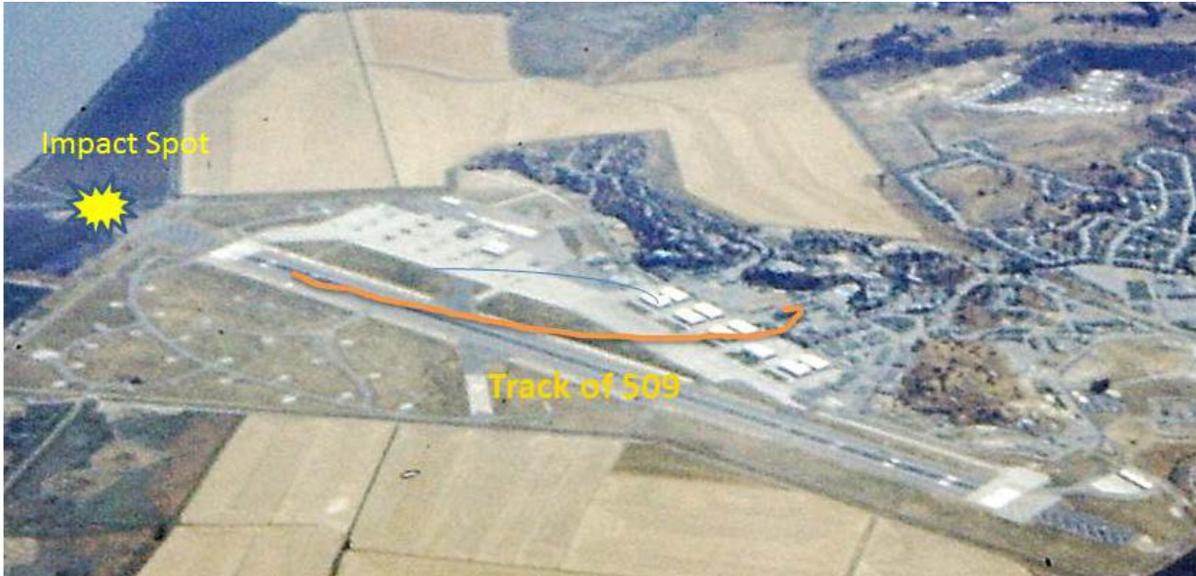
Fig 4. Impact and Slide

Here is a graphic that shows the general track of the slide, as well as the original impact points.

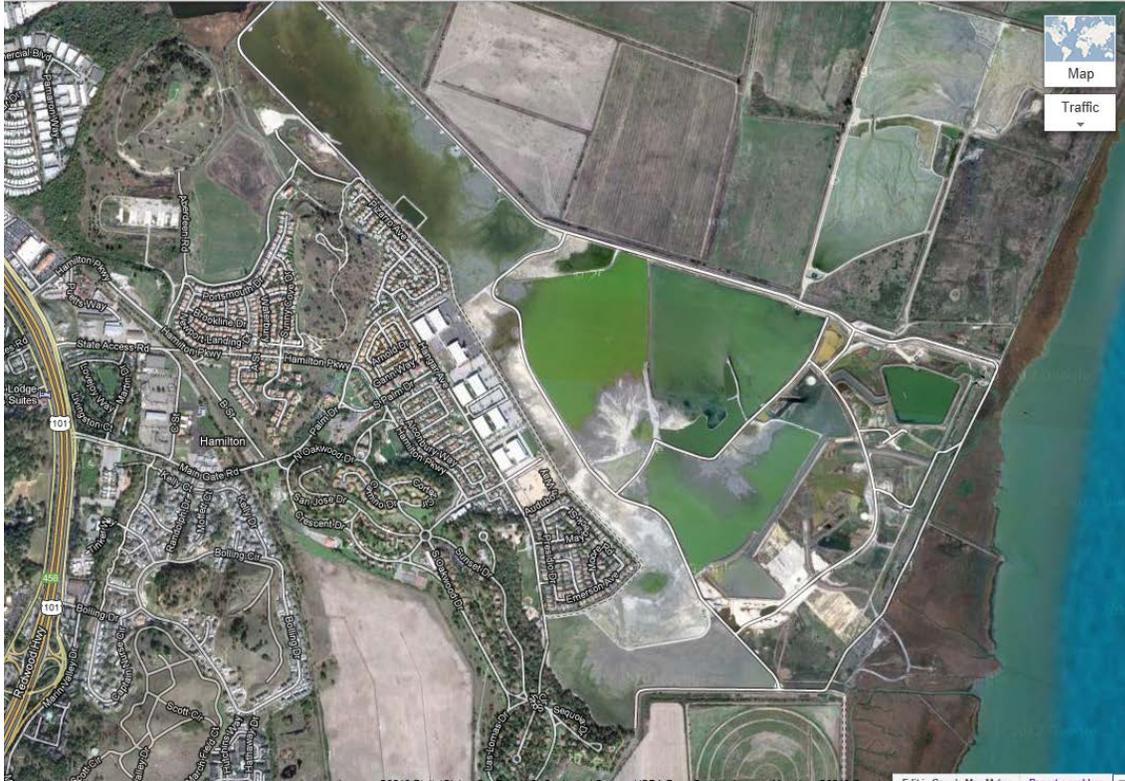
Fig. 4. Hamilton Today! (The runway area is known as “Hamilton Wetlands.”) You can still see the dyke, swamp and overrun.
