FINAL RESULTS OF THE NASA STORM HAZARDS PROGRAM

Bruce D. Fisher
NASA Langley Research Center
Hampton, VA 23665

Presented at the International Conference on
Lightning and Static Electricity
April 19-21, 1988
Oklahoma City, Oklahoma

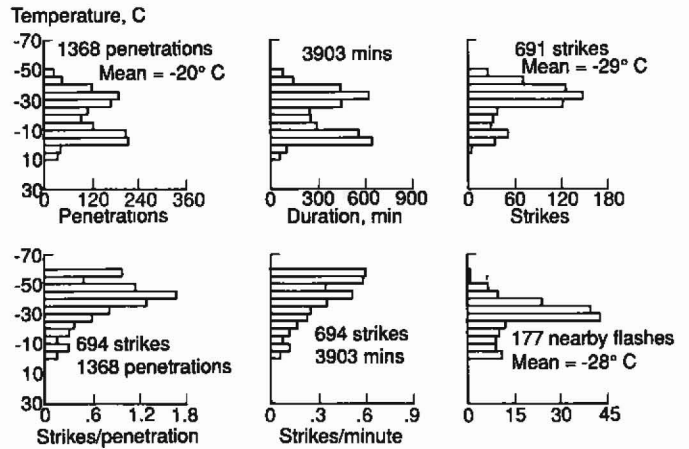
Fig. 6. Thunderstorm penetrations and lightning statistics as a function of ambient temperature for Storm Hazards '80-'86.

Histograms showing the number and durations of penetrations, and the number of strikes and nearby flashes experienced from 1980-1986 are shown for altitude intervals of 2000 ft in Figure 5, and for ambient temperature intervals of 5°C in Figure 6. Penetrations were made by the F-106B airplane at pressure altitudes ranging from 2400 ft to 40 000 ft with a mean penetration altitude of 22 900 ft (Fig. 5). Temperature data (mean value during the penetration) were available for 1368 penetrations, with values ranging from 20°C to -60°C, with an overall mean value of -19°C (Fig. 6). The distributions of penetration duration time with altitude and ambient temperature are very similar to the corresponding penetration distributions.

were experienced (see Table 2). Starting in 1982, the NASA Wallops UHF-band radar was used to guide the F-106B airplane through the upper electrically-active regions of thunderstorms [8 and 24], resulting in hundreds of high altitude direct lightning strikes (Table 2 and [8, 10, and 20]). Starting in the 1984 season, the UHF-band radar was used to provide guidance to electrically-active regions in thunderstorms at altitudes below 20 000 ft [9], the same range of altitudes studied previously in 1980 and 1981. The low altitude research efforts of 1980-81 and 1984-86 are shown in the low altitude/warm temperature peaks in the penetration and duration data in Figures 5 and 6.

The Storm Hazards Program strike statistics shown in Figures 5 and 6 differ significantly from the published strike data for commercial aircraft ([1 and 2] - see Fig. 7) and for U.S. Air Force aircraft [3], in which most lightning strikes were found to occur between ambient temperatures of $\pm 10^{\circ}\text{C}$. In the Storm Hazards Program, direct strikes were experienced at pressure altitudes ranging from 14 000 ft to 40 000 ft with a mean value of 20 600 ft (Fig. 5). The corresponding ambient temperature values ranged from 5°C to -65°C , with a mean value of -30°C (Fig. 6). The nearby flash data are very similar to the direct strike data.

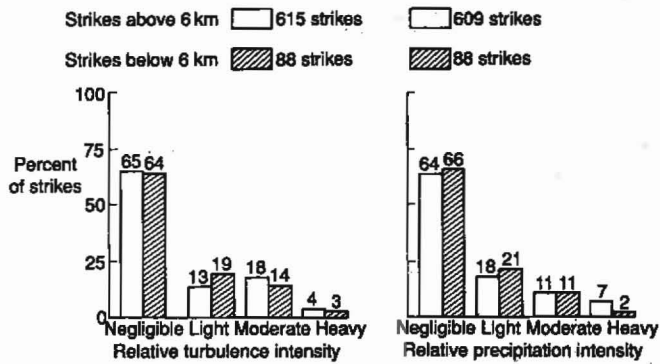
Fig. 8. Relationship of lightning strikes to relative turbulence and precipitation intensities for Storm Hazards '80-'86.

Unlike the temperature and altitude data discussed above, there is no discrepancy between the precipitation and turbulence data gathered in this program and that data gathered during commercial [1 and 2] and military operations [3]. As before, the data are in agreement with those from the USAF/FAA Convair 580 program [27]. Commercial aircraft reported that 77 percent of all strikes occurred in light to moderate turbulence, with 22 percent of all strikes occurring with no turbulence. Eighty-one percent of all commercial strikes occurred in rain; only 2 percent of the strikes were associated with rain and hail. For military aircraft, only 20 percent of the strikes were associated with turbulence, 67 percent of the strikes occurred in rain, 5 percent occurred in hail or snow, and 10 percent occurred in "clear air." Finally, for the Convair 580 research program, 90 percent of the strikes occurred in light to negligible turbulence; all the strikes were associated with rain. In summary, the thunderstorm research data gathered by the NASA F-106B airplane and the USAF/FAA Convair 580 airplane, as well as the commercial/military data, have shown that the number of direct strikes to aircraft do not show a positive correlation to turbulence and precipitation intensities.

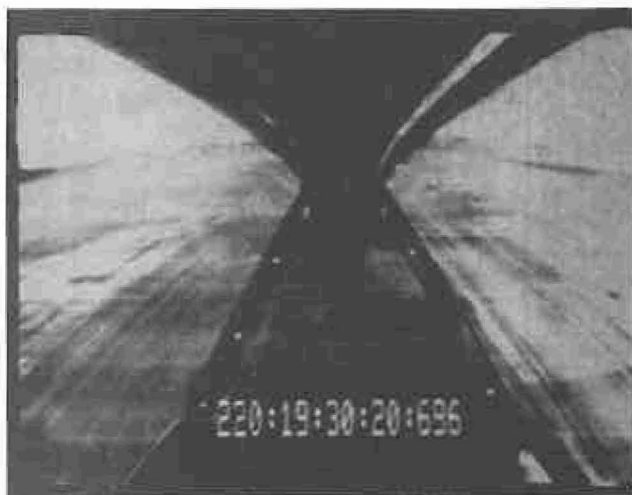
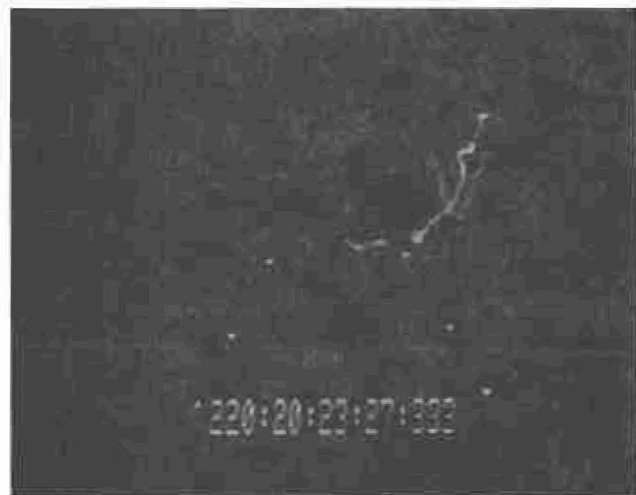
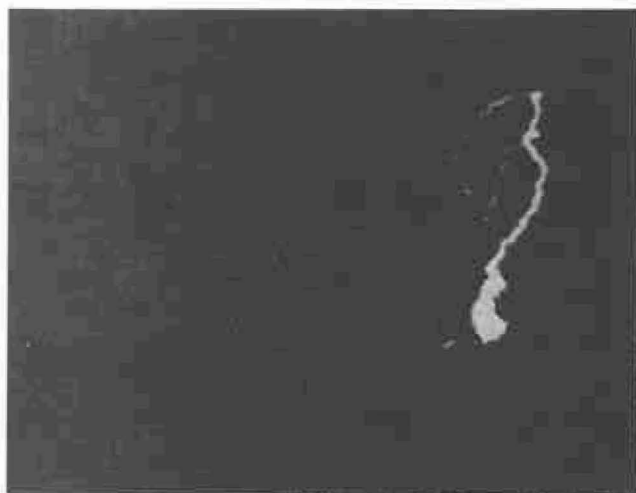
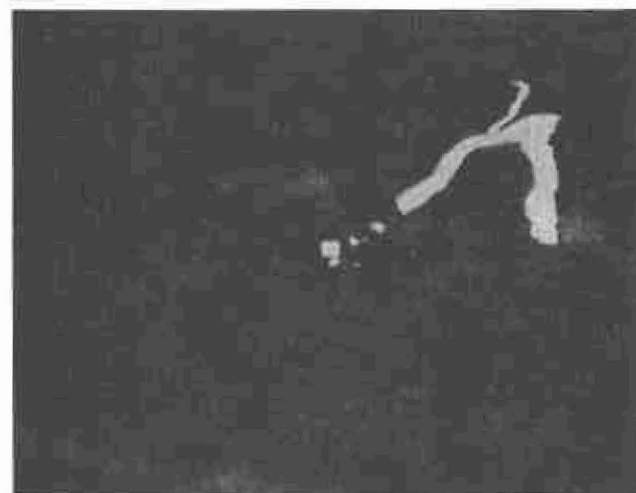
(a) Reference shot taken on the runway in sunlight.

(b) Frame 1. 20:23:27.333 UT.

(c) Frame 2. 20:23:27.367 UT.

(d) Frame 3. 20:23:27.434 UT.

Fig. 10. Photographs of strike 23 of 1986 from the cockpit-mounted, forward-facing video camera.

This same channel and structure also can be seen in three successive frames from the cockpit-mounted, forward-facing video camera (Fig. 10). Figure 10(a) shows a reference shot from this camera in daylight on the runway; the airborne frames are shown in Figures 10(b-d). The lightning channel appears to be ahead and above the nose boom at 20:23:27.333 UT (Fig. 10(b)); in the next frame, at 20:23:27.367 UT (Fig. 10(c)), the channel appears closer to the aircraft, to the right of the forward fuselage. Finally, in the third frame, at 20:23:27.434 UT (Fig. 10(d)), the channel is attached to the nose boom, with the same characteristic loop and tortuosity as shown with more clarity in the still photographs (Fig. 9).

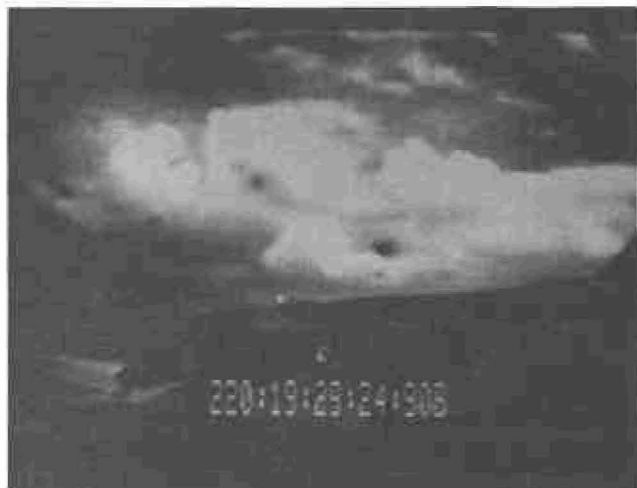
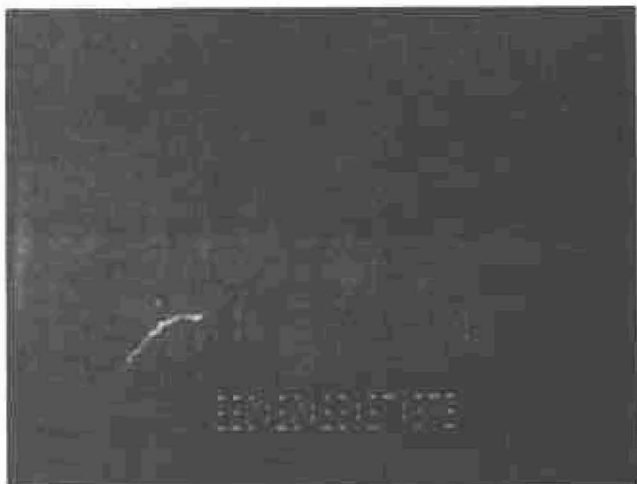
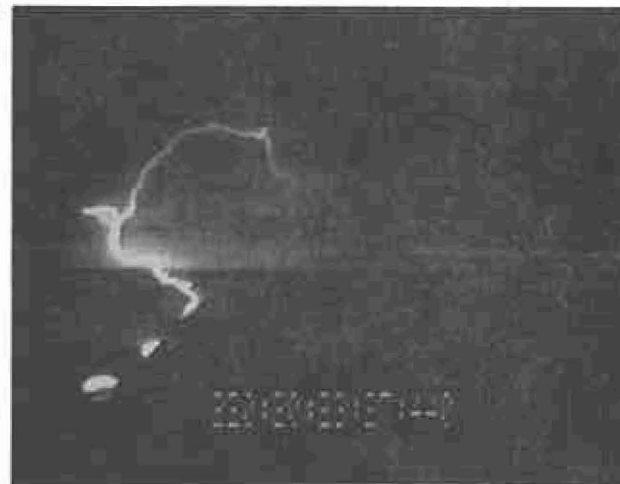
(a) Reference shot taken on the runway in sunlight.

(b) Frame 1. 20:23:27.338 UT.

(c) Frame 2. 20:23:27.372 UT.

(d) Frame 3. 20:23:27.440 UT.

Fig. 11. Photographs of strike 23 of 1986 from wing-tip mounted, cockpit-facing video camera.

The corresponding views from the forward-facing camera on the left wingtip are shown in Figure 11. Similarly to Figure 10, the data frames (Figs. 11(b-d)) are preceded by a reference frame taken in daylight (Fig. 11(a)). From the wing-tip vantage point, it is not possible to determine conclusively if the lightning channel actually attaches to the nose boom. However, it appears that the channel is attached at 20:23:37.44 UT (Fig. 11(d)). No lightning channels are visible in the fields of view of either forward-facing video camera following this time. The similarity in the tortuosity and geometry of the lightning channel shown in Figures 9-11 provides assurance that the same channel is being observed.

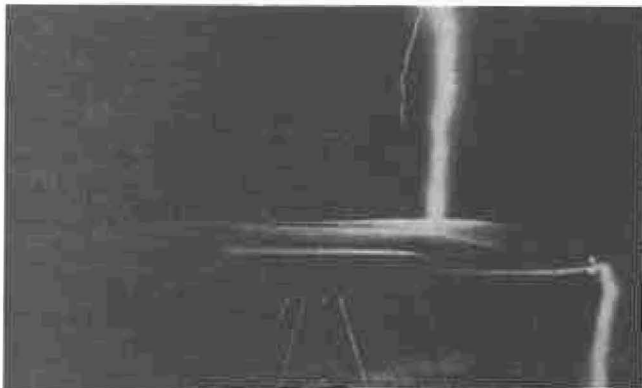
Fig. 14. Strike attachment to canopy with exit from nose boom of scale model. Rod electrode positioned above canopy area; positive-polarity electrode.

Typical initial leader attachments to the scale model are shown in Figures 14-16. The scale-model tests showed initial attachment points to include the radome and nose boom (Fig. 14), canopy (Fig. 14), forward and center fuselage areas, wing tips (Fig. 15), engine inlet, engine exhaust nozzle (Fig. 16), and vertical fin (Fig. 15). In addition to wing-tip attachments, some leaders also attached to the wing leading edges (Fig. 16). In fact, on some tests multiple leader attachments between the rod electrode and the airplane were noted (Fig. 15).

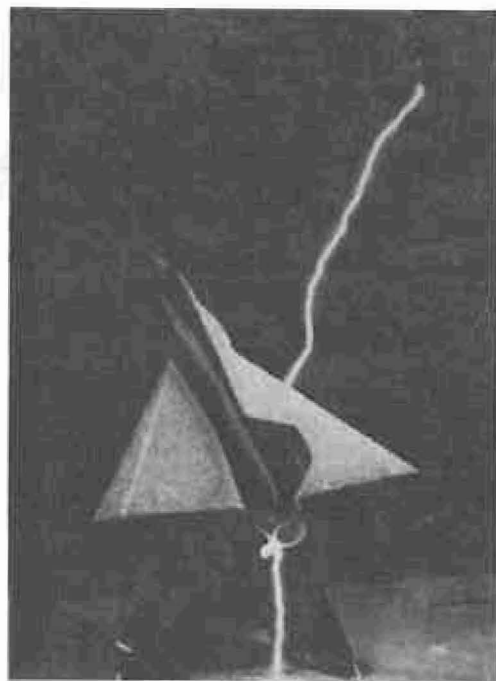
Fig. 16. Strike attachments to leading edge of left wing with exit from engine exhaust area of scale model. Rod electrode positioned equidistant from nose boom and right wing tip; model pitched 45° nose up; positive polarity electrode.
