Interceptor

volume 9
number 8
ADCP 107-2

Air Defense Command
Lt. Gen Arthur C. Agan, Jr.
Commander

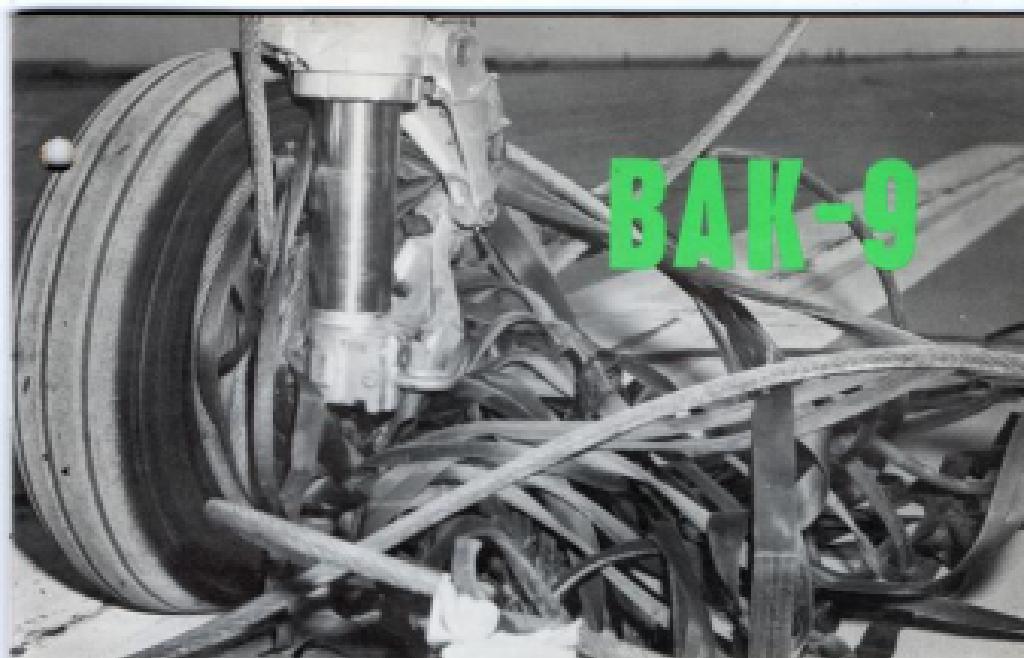
With the help of AIRSCDOP Magazine we thought that it was time to refresh everyone's memories on BAK-9 barriers. To start with, we have a regulation which specifies who is responsible for inspection of the barriers:

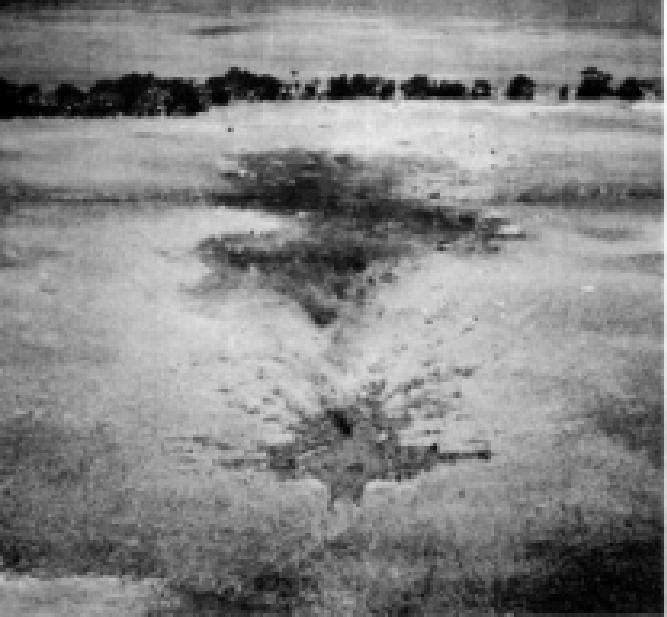
Dramatic impact of aircraft at impact point.

It is unknown why the Instructor Pilot allowed a dangerous situation to progress; however, it is felt that he did attempt to recover after the aircraft had penetrated the fog bank. Disorientation caused by poor visibility and lack of reference with the ground probably contributed to momentary confusion. This confusion delayed recovery attempt until it was too late. This would account for the advance in engine rpm from 80 percent (normal penetration rpm) to 90 percent or higher (known rpm at impact). It would further account for the increased airspeed (309 KIAS at impact) and the obvious high positive "G" loading as indicated by the size and depth of the impact hole.

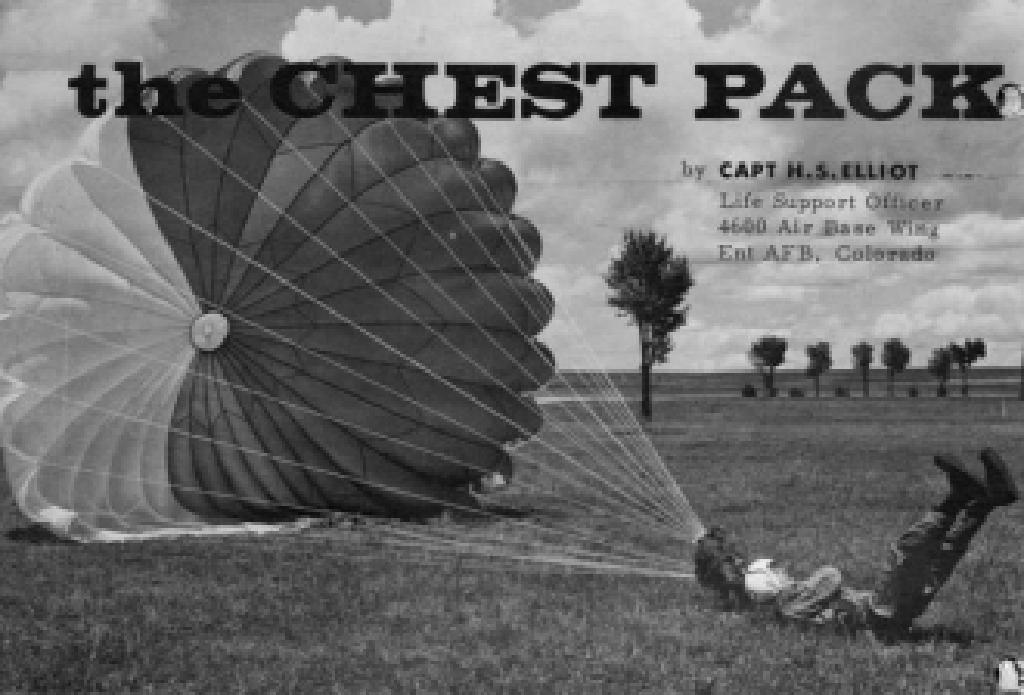
One chute disconnected - with chute still in full blossom.

This brings us to the second difference. As you can see from the pictures, retaining one riser doesn't do a thing for you. If you're on the ground, it'll cock your body. If you're in the water, it'll twist you through the water. You're still going to be dragged unless you get both releases as soon as you touch the ground or water.

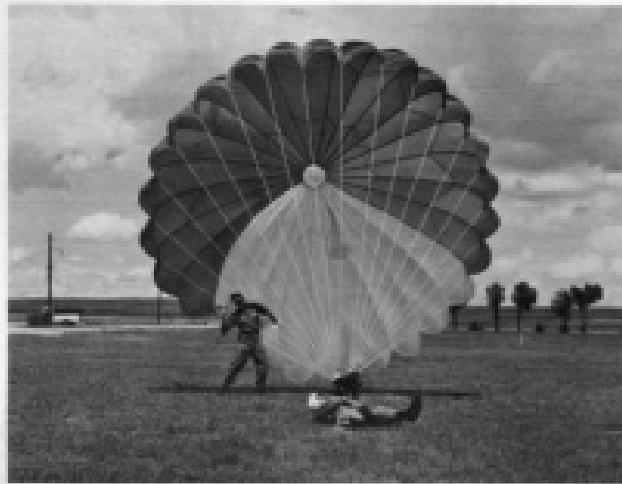
Notice cross position of body during drag.

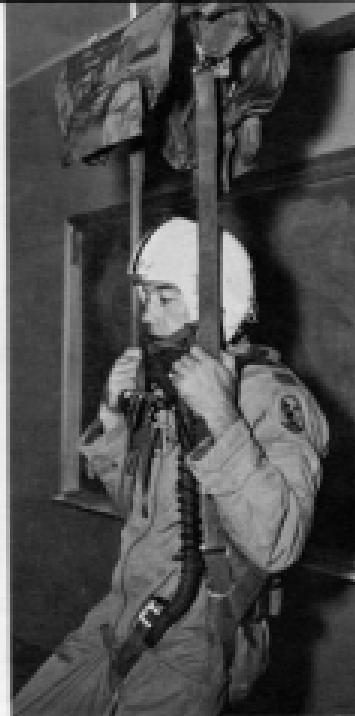
Harness and risers of chest pack.

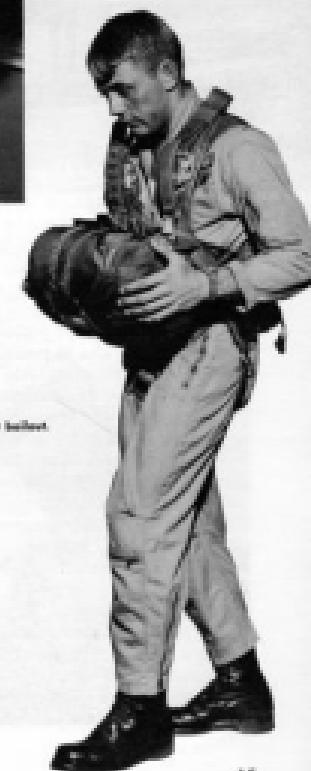
Chest pack position for bailout.

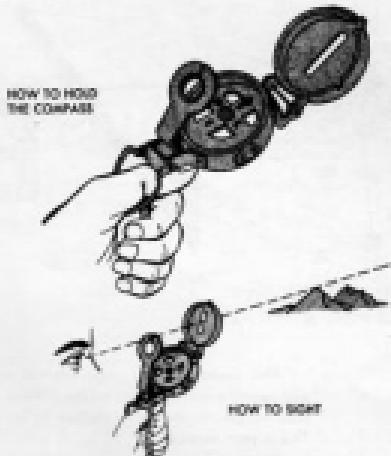
Figure 8-17. How to Use a Lensatic Compass

V The lensatic compass can be an accurate and reliable instrument under survival conditions, when properly used. Use this compass for ground navigation to determine a bearing to an objective, to establish your position by taking sights on two or more recognizable landmarks, and to continually check your course of travel. To use this compass, hold as shown in Figure 8-17 sighting your objective through the slit in the top of the rear sight and past the wire in the slot of the cover. Level

your compass so the dial moves freely when held in sighting position. Without moving the compass, look through the magnifying glass in the rear sight, and read your heading under the fixed line on the glass. All readings on this compass are magnetic. The compass can be used to orient a map. Orienting a map consists of making north on the map coincide with true north. To orient your map, lay it out flat, place the compass on it so that the sights are parallel to the north-south grid lines. Next rotate the map and the compass together until the needle coincides with the fixed line on the compass glass. This is a magnetic bearing. To get a true bearing, continue to rotate map and compass until the needle indicates the proper magnetic declination for the area. The map is then oriented and all directions on the map coincide with those on the ground. To determine a bearing, place the center of the compass over your position on the oriented map. A line from the center of the compass to your proposed designation will give you the bearing to follow. (AFM 54-4)
